# TECHNICAL BULLETIN

## TB-0028

### 11kV RECLOSERS FROM NOJA

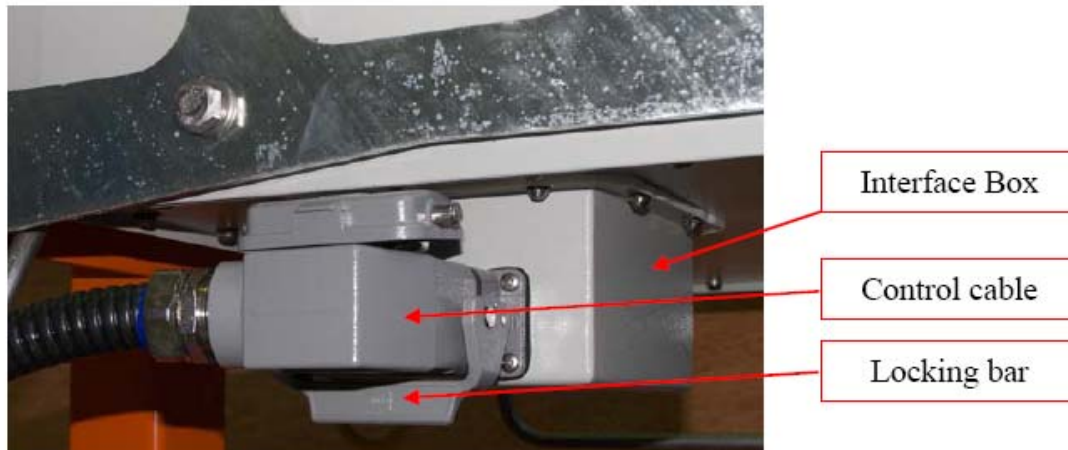
OSM pole mounted recloser (s/n 150651) installed in Integral Energy was found to have some problem with operation and indication. On return to NOJA Power it was found that the recloser had the water penetration into the interface box where control cable is connected.

**Figure 1: Connection of control cable to the recloser connector.**

The connection of the recloser control cable to the recloser tank is done through Harting connector. This connector has IP65 rating when it is locked in place. The interface between plug and socket has a rubber gasket. If the connector is not locked properly or some items are caught between plug and socket, this would compromise IP65 rating.

It is recommended that during the installation of OSM reclosers care should be taken to ensure that no items are caught between the plug of the control cable and the socket on the recloser tank. Also, installation crew must ensure that the control cable is properly locked in place.

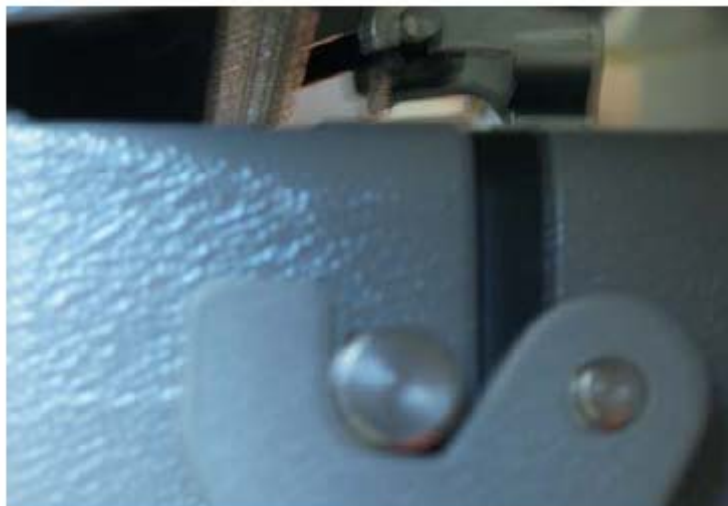
**Figure 2: Control cable locked in place**

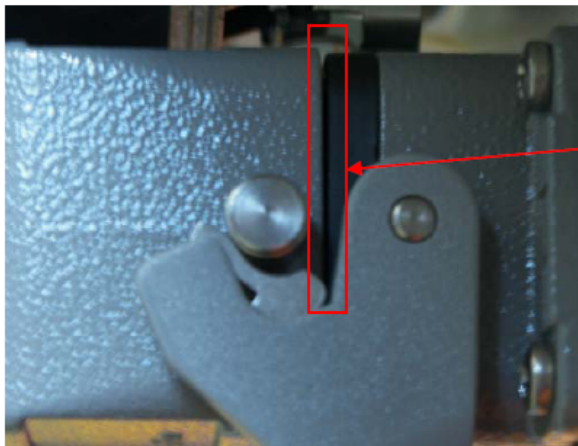
Gap between the cable and connector when the cable is not locked.

**Figure 3: Control cable not fully locked**

These measures will ensure that no water penetration will take place into the interface box which might affect the operation of the recloser.
