# Technical Bulletin

## TB 0277 – Fibreglass Cubicle Securing Improvement

To outline fibreglass cubicle security improvements and retrofit options for existing substations where required.

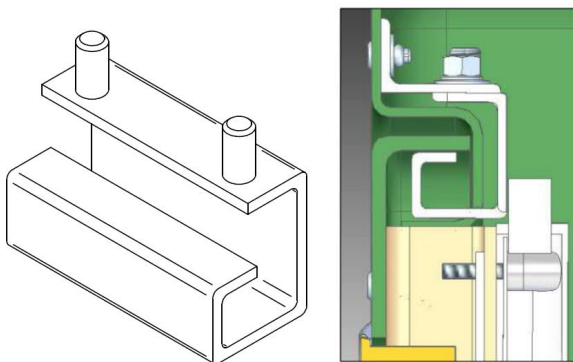
A new striker plate shown in Figure 1 has been deployed on all new fibreglass padmount substations since early 2018. The striker plate reduces the movement of the door over time. The striker plate is available as an inventory item as indicated in Table 1 and can be retrospectively installed in high risk areas.

Figure 1: Design drawings for new Striker Plate design retrofit to current cubicle fibreglass design

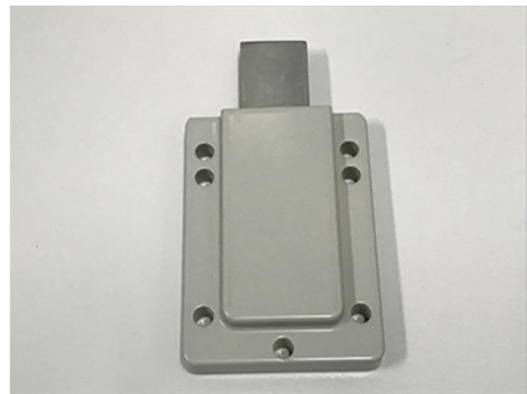
Figure 2: Additional Durabolt backset with retroactive striker plate upgrade

1. Whenever a site is accessed, the cubicle doors are to be checked secure, adjusted as required and fitted correctly as outlined in *SMI160 – Distribution Substations*. This includes the cubicle door feet, which need to be adjusted to ensure the door is firmly secure;
2. High-risk sites for unauthorised access presented by non-fitted, damaged or unsecured doors on an existing cubicle can be upgraded with the Striker Plate installed according to the 'Retrofit Security Striker Plate P204' manual attached. For retroactive replacements contact Security Section (Table 2) for replacement of the existing lock with Durabolt back (Figure 2);
