# TECHNICAL BULLETIN

## TB-0192

### ILJIN LBS semaphore cover defect

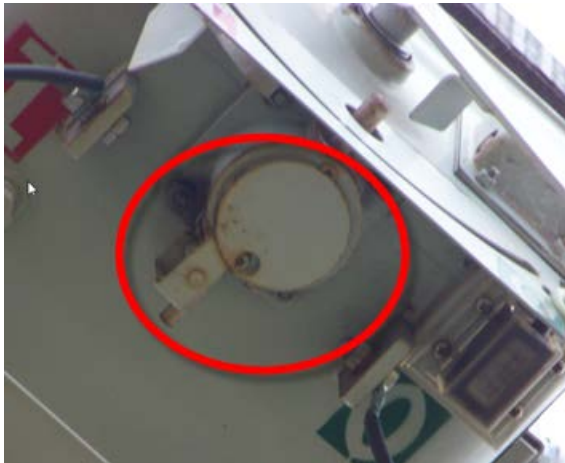
**Figure 1 – Normal Iljin LBS condition (no defect)**

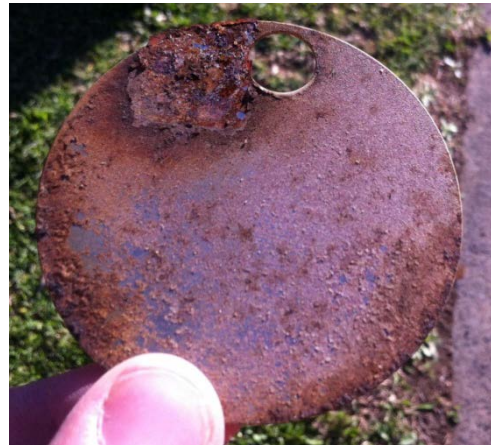
There have been two cases where, during switching operations, the semaphore cover has corroded and the spot welds have failed. Subsequently, the semaphore covers have fallen to the ground.

**Figure 2 – Semaphore cover corroded off**

- The manufacturer (AK Power) was notified of the defective semaphore cover design and was asked to provide a solution.
- The manufacturer designed a retrofit kit to be installed on the existing defective semaphore cover brackets.
- The retrofit kits are available through stores with the stock code: **001565985**

If any Ijin LBS are found to have a missing semaphore cover a defect shall be raised with a 6 month defect priority.

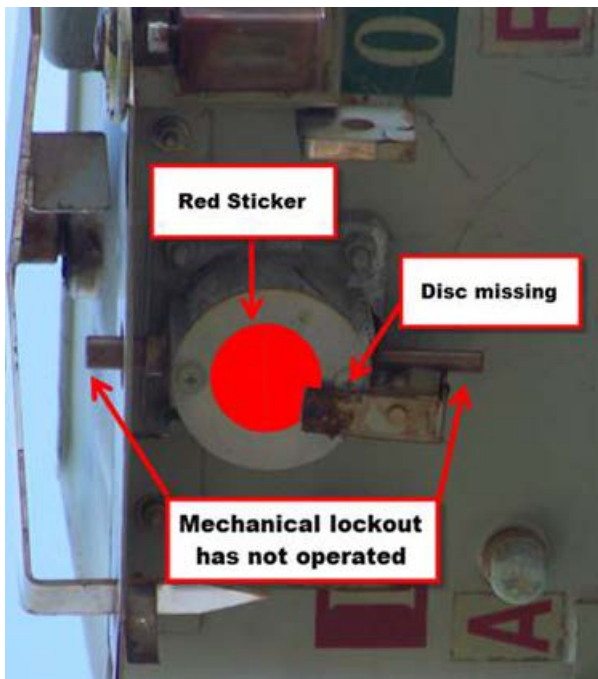
When this defect occurs, the switch is still safe to operate as the low gas mechanical lockout has not been activated. Another issue that has been observed is that the red low gas indicator sticker may have also fallen off the low gas mechanical lockout.

Figure 3 – Cover missing, showing low gas indication sticker (still operational)

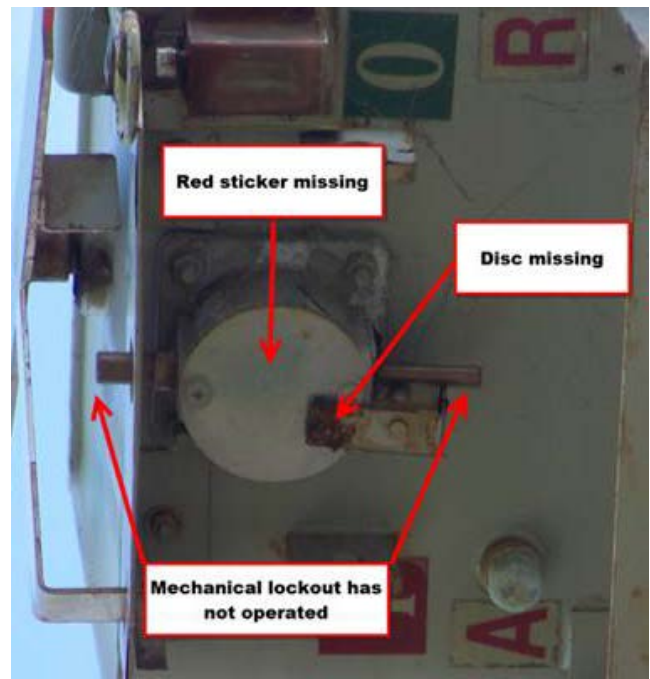
Figure 4 – Cover missing, red low gas indication sticker missing (still operational)

In the event that the red indicator has come off the device, replacement stickers are provided. Place the red sticker onto the device as shown in the adjacent photo.

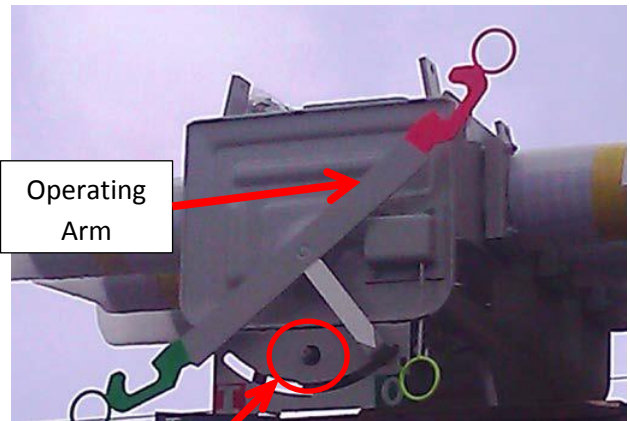
1. Assessing the position of the rod (circled in red in the adjacent figure). In this example, the rod has protruded by approximately 100mm and is preventing the movement of the operating arm. In this case, the switch **has locked out due to a low gas**.
2. Assessing the position of the bracket that the semaphore cover is normally attached to (circled in yellow in adjacent figure). In this example, the bracket is facing towards the switch indicator and is thus considered to be operational.

If the operating arm of the switch is impeded by the protruding rod (circled in red), the switch **has locked out due to a low gas** and cannot be operated.

If the bracket (circled in yellow) is facing the indicator as shown in this figure, the switch is considered operational.

If the switch is considered faulty, report this back to the control room and **do not** install the semaphore cover.

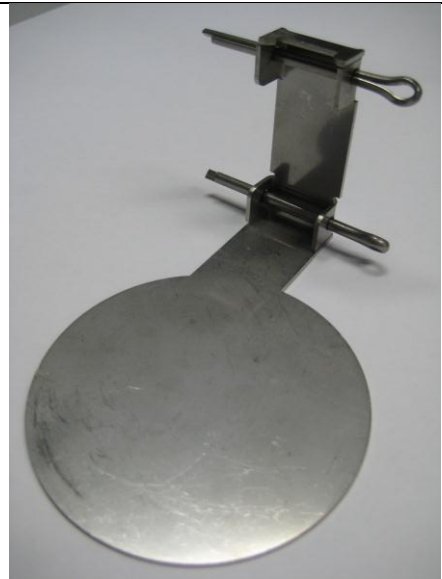
The replacement semaphore cover is shown in the picture on the right. Two split pins will be included in the assembly.

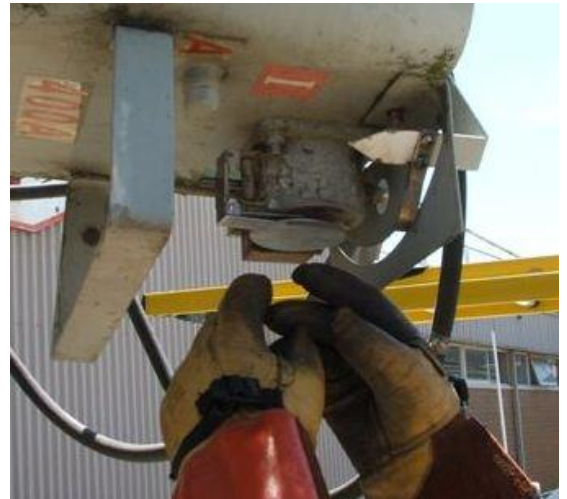
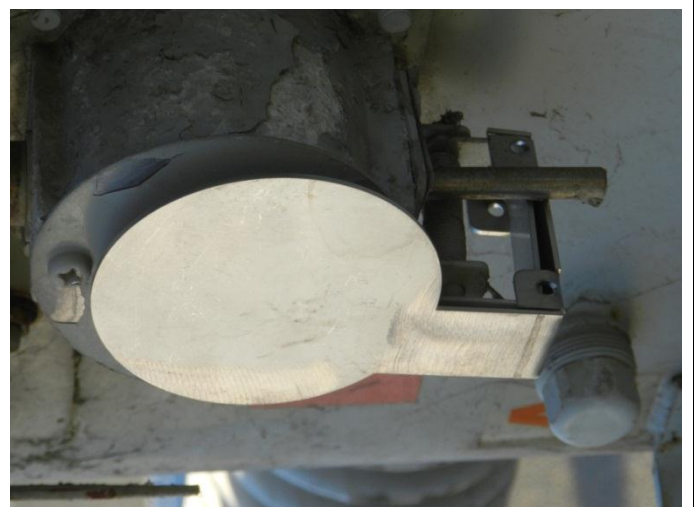
Mount the replacement semaphore cover on the back of the existing semaphore bracket / arm as shown in the adjacent figure.

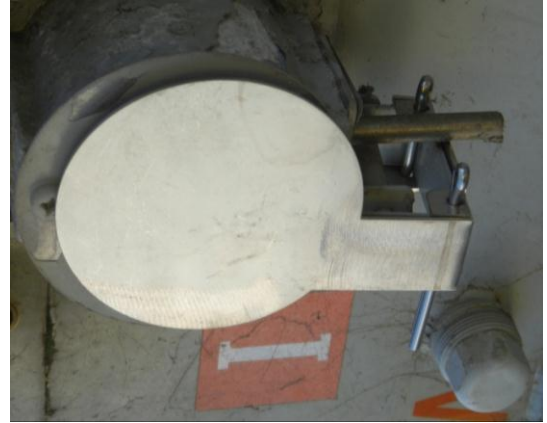
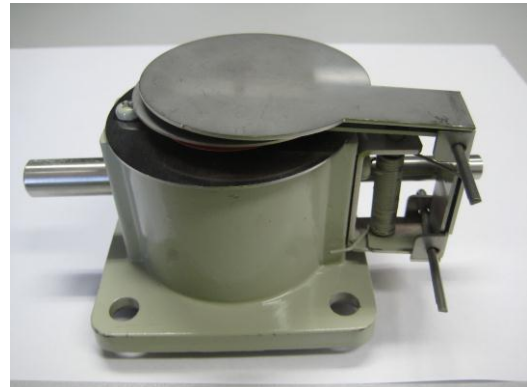
Place the split pins through the existing holes in the replacement cover as indicated in the adjacent figure.

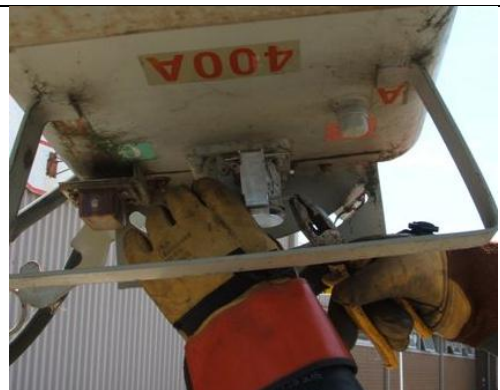
Using approved pliers, bend the pointed ends of the split pins to flare them out to ensure they stay in place. This completes the installation.
