## Mains Maintenance Instruction

# Pole and line inspection and treatment procedures

### MMI 0001 Pole and line inspection and treatment procedures

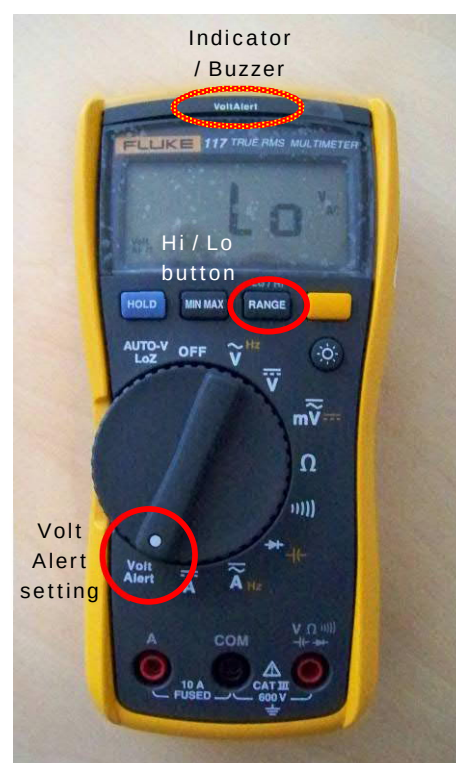
Using a high impedance (Z) capacitively coupled measuring device, such as a *Fluke 117* meter on the **Volt Alert** setting and on **Lo** RANGE, stand approx one (1) metre from the

Figure 1: Multimeter voltage tester

pole and extend at elbow height, moving towards the pole, and touch the surface.

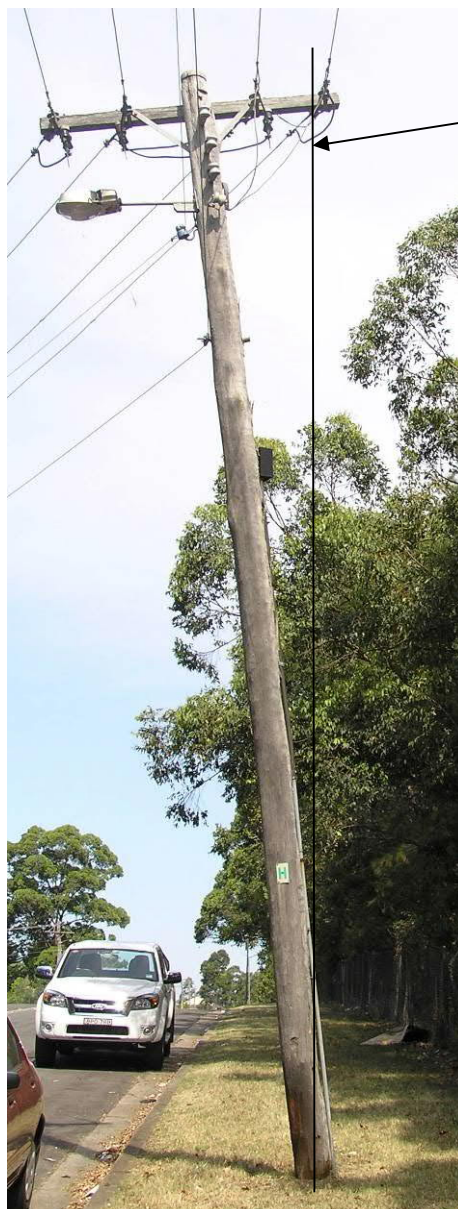
- a) Vertical alignment. Check if the pole is leaning or bending. A pole that is vertical in ground but bending due to structural pole top loading is not considered serious unless there are knot holes or splitting of the timber. Consider whether the pole alignment compromises conductor clearances or obstructs traffic on a road or driveway.

Example of a pole with a 7° lean.

This level of lean increases sag in the adjacent spans, reduces ground clearance and results in the conductor being more prone to conductor clashing under wind and fault conditions.

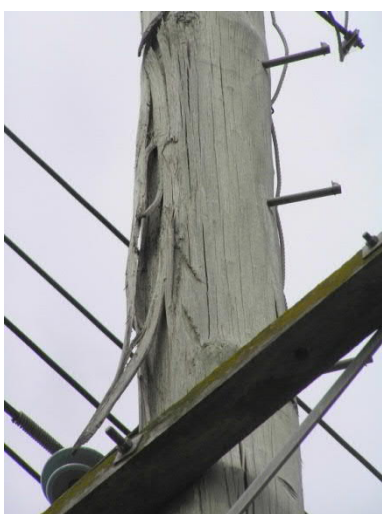
**Figure 4: Loose sapwood on FPT pole**

All FPT poles that have loose sapwood, as shown in **Figure 4** to **Figure 6**, must have the words "CCA Sapwood Failure" added to the comments of the inspection work order field in the data capture tool.

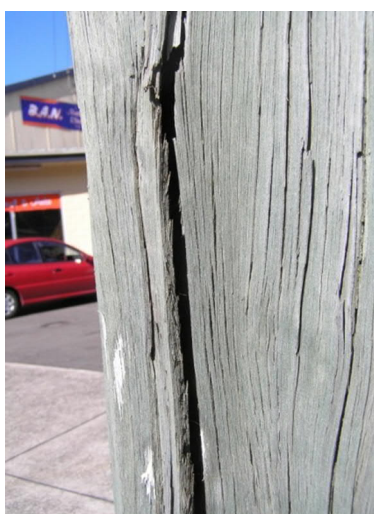
**Figure 5: Loose sapwood on FPT pole**

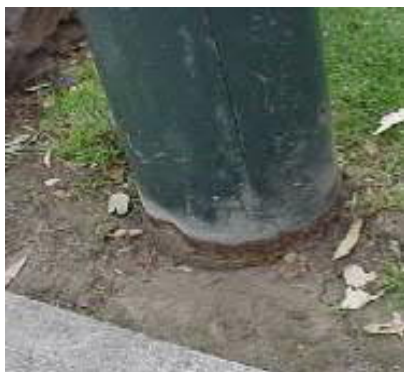
The presence of rust holes or significant vehicle impact damage may require the replacement of the pole. Examples of steel poles that require replacement is shown in **Figure 7 to Figure 9**.

**Figure 7: F**  
**base of po**  
**a**

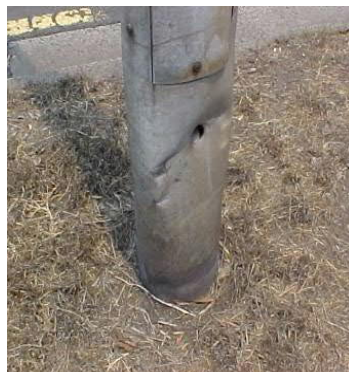
**Figure 9: Vehicle**  
**Impact damage**

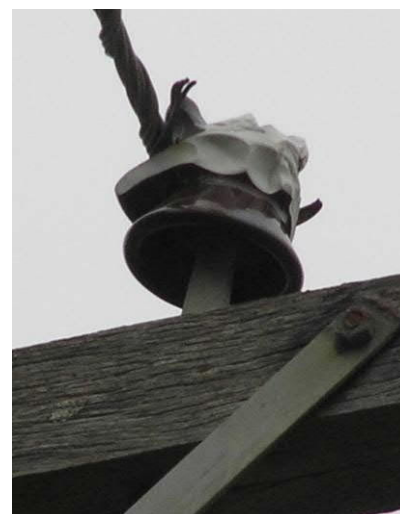
**Figure 11: Damaged HV pin insulator (possibly caused by firearm) and broken tie wire**

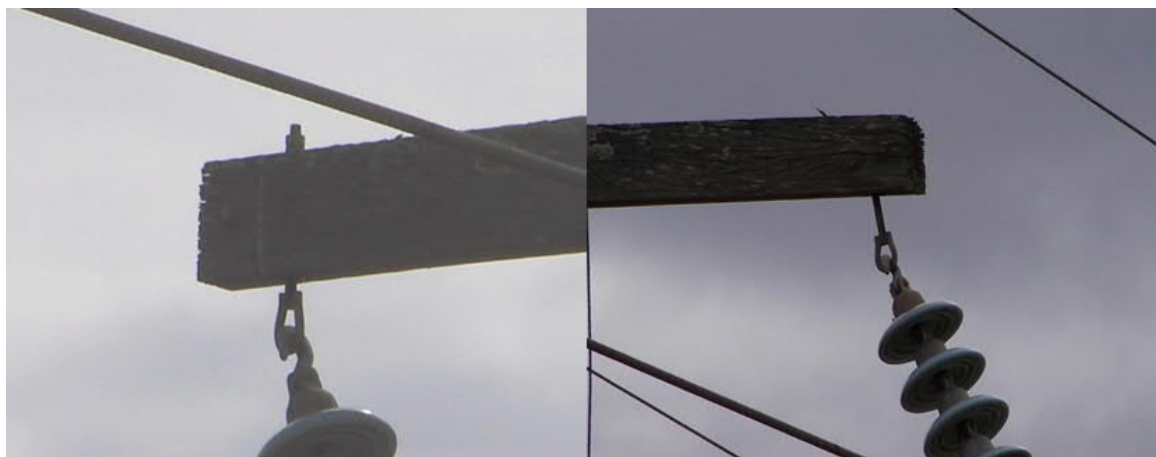
An example of elongation of the crossarm pin mounting holes is shown in Figure 10. This condition is more prevalent where a large conductor at high tension and some angle of deviation exists. Where possible, check if the suspension insulator bolt is slipping through the crossarm, as shown in Figure 12. It may be necessary to observe this from an adjacent pole with the aid of stabilised binoculars.

**Figure 12: Correct bolt and insulator construction (left) compared to a bolt which is slipping through the crossarm (right)**

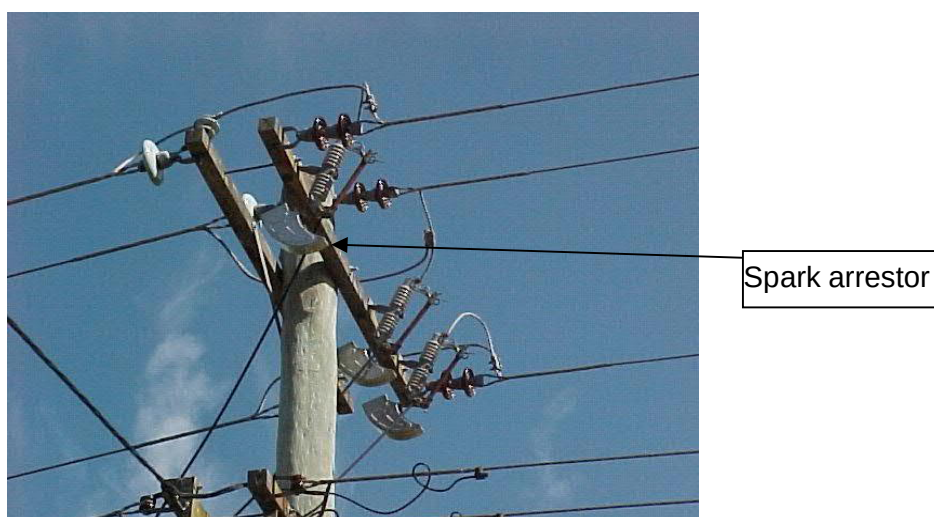
Where spark arrestors are installed on the fuses, the complete fuse assembly is likely to be an older style and must be defected and recorded for replacement (refer to **Figure 14**).

**Figure 14: Dropout fuse spark arrestor**

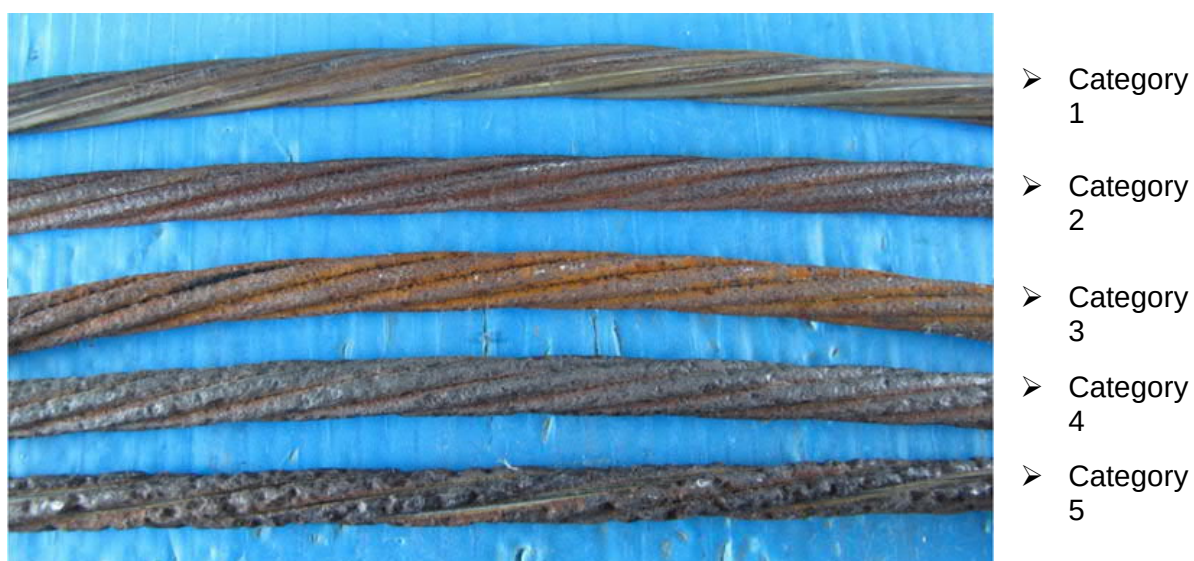
For overhead steel conductor inspections, particular attention should be given to the colour and pitting of the metal as well as fraying or broken strands. Other contributory factors such as the location of the overhead mains (e.g. bush fire prone area), and the criticality of the feeder may be included in a risk assessment. The risk assessment may necessitate a more immediate defect prioritisation than those given in the table below.

The following figure and table provides guidance on the prioritisation of defects for the condition of overhead steel wires:

**Figure 16: Steel conductor condition/corrosion categories**

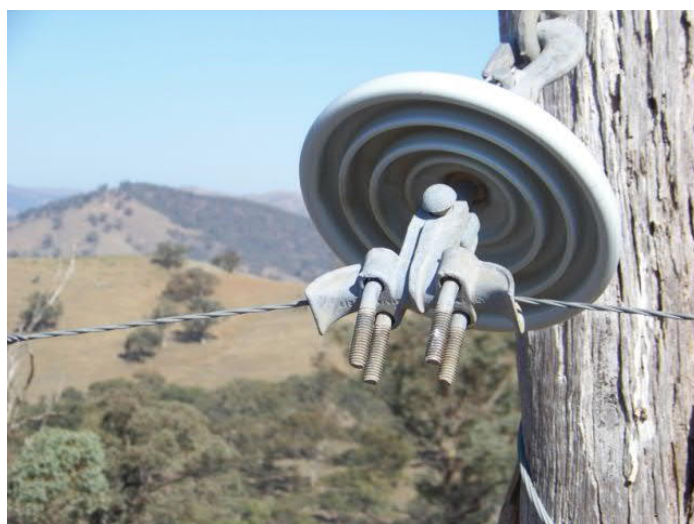
Connections and bolts at the pole top must be inspected for signs of looseness, and that all bonds are securely attached to supporting pin insulators where required.

**Figure 17: Missing nuts and washers on suspension clamp**

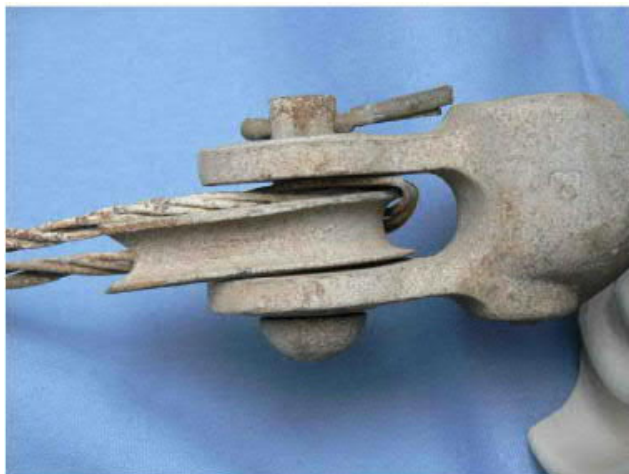
Conductor terminations are to be closely inspected to verify the correct fitment of the helical termination (dead-end) such that it is free to move with any movement of the conductor.

**Figure 18: Incorrectly fitted helical termination**

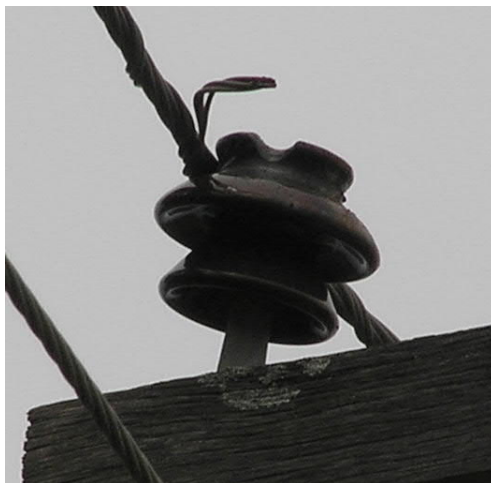
**Figure 19: Broken HV tie wire**

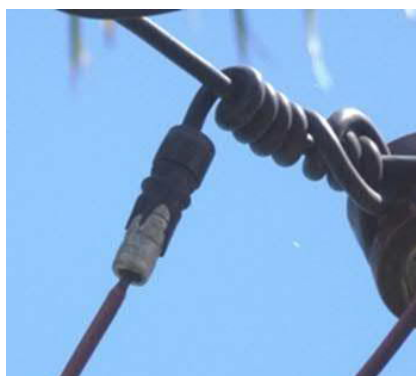
Figure 22: Faulty insulink

- Insulink and/or cable insulation burnt or melted.
- Bare conductor observable at the point of entry into the insulink.
- Ultra-violet affected insulation resulting in fading, cracking, or holes in the insulation between the end caps.
- Insulinks not crimped or crimped incorrectly, for example, inadequate indentation marks, incorrect number of crimps – two (2) crimps on either side of the insulink – or not crimped in the correct location.
- Check the insulinks are orientated vertically, with the aluminium service cable on top and the customer's copper consumer mains below.

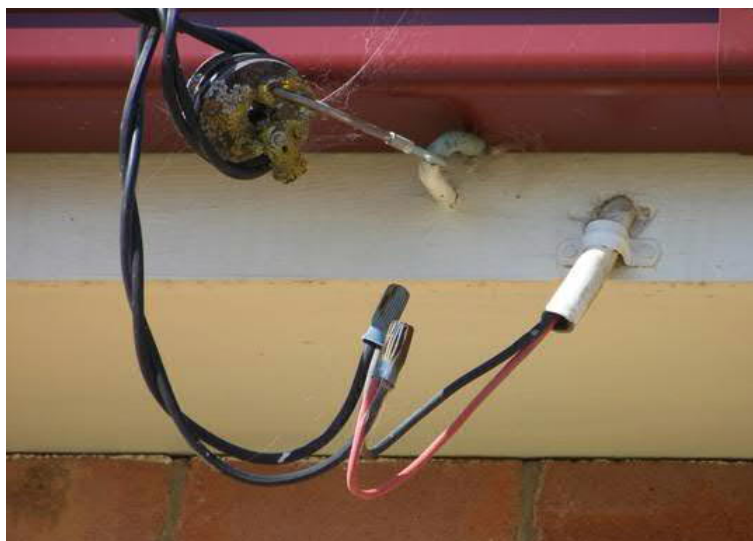
**Figure 23: Blue point connector**

In some locations throughout the Blue Mountains and outer western areas, Blue point connectors are in use.

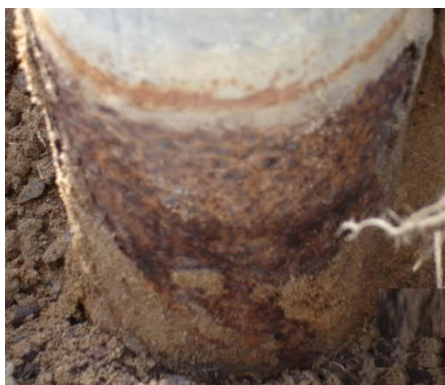
The pole must then be checked for the full extent of rust degradation.

**Figure 24: Rusted and flaked below groundline section of a steel pole**

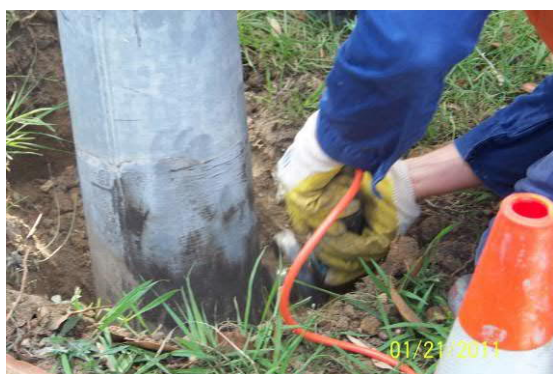
A wire brush, an angle grinder with a sanding disc or metal grinding disc will typically be required to clean the surface to a suitable state. Only the minimum amount of material should be removed in order to achieve a contact patch for the meter. Use of any brushing or grinding attachment must be confined to spot cleaning the localised areas for measurement. General grinding of the pole face is not acceptable. Pole treatment as described in section 5.14 will be necessary following any surface grinding or sanding.

**Figure 25: Test surface preparation**

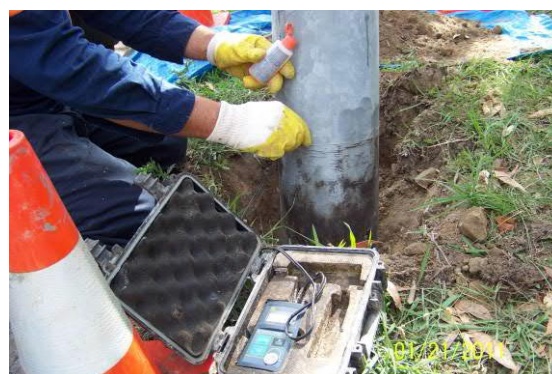
Where visible above ground corrosion is present, it must be completely removed and a wall thickness measurement taken. A smooth, level surface is required to obtain an accurate reading with an ultrasonic meter.

**Figure 26: Testing the wall thickness**

When measuring the nominal wall thickness, the area on, or immediately around the access cover if fitted, must not be used because the steel wall in this area is reinforced and may be thicker than normal.

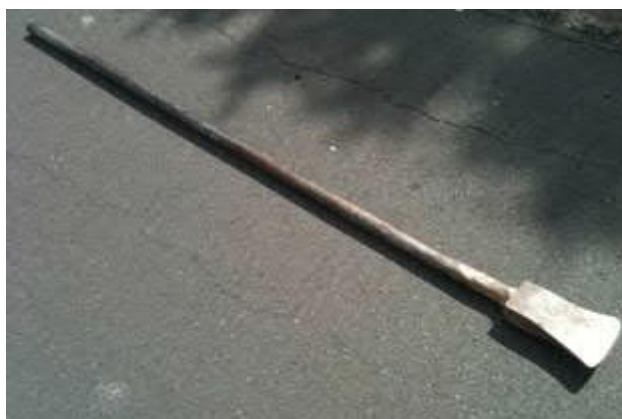
**Figure 31: De-sapping bar**

Remove any rot affected sapwood with a de-sapping bar (see below) and treat with preservative as described in clause 5.13.

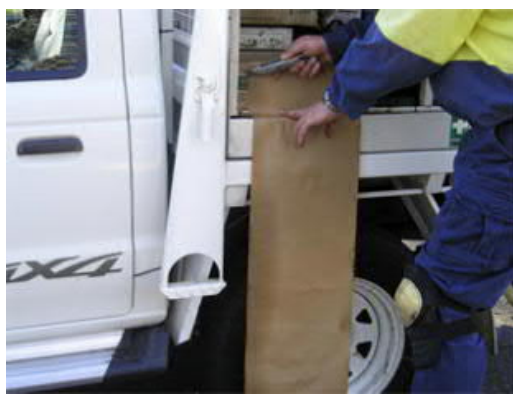
**Step 1:** Preferably, leave the *Ausplast* in original box. Cut to a manageable length (two [2] pieces recommended) to correspond to the girth and any obstructions. – Photo 21

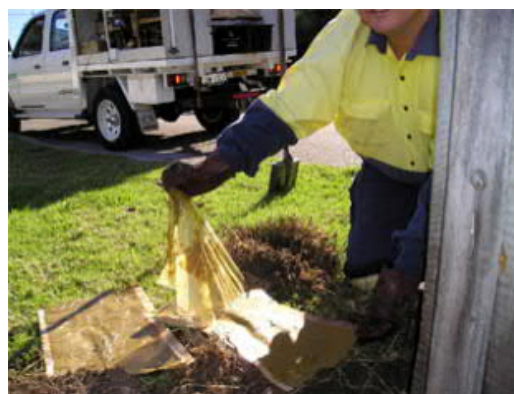
**Step 2:** Remove plastic film backing prior to installation. Photo 22

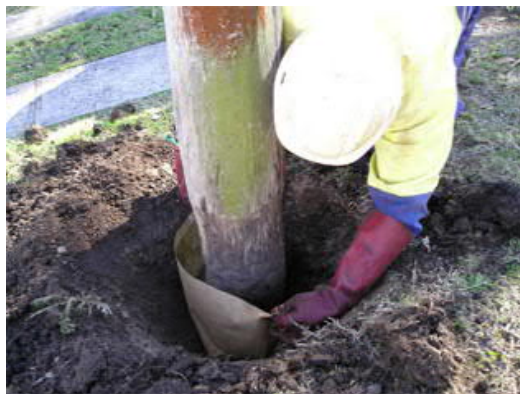
**Step 3:** Place each piece of *Ausplast* 50mm below surface and cover entire circumference. Photo 23

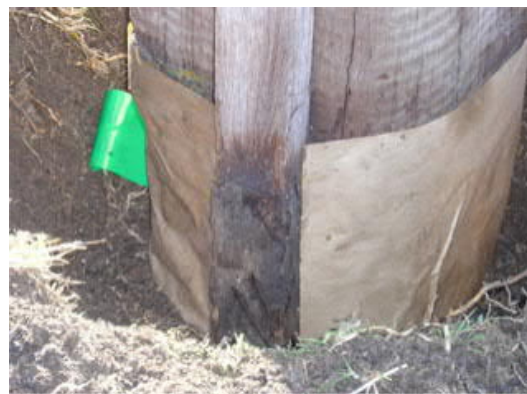
**Step 4:** *Ausplast* must not wrap around obstructions. Butt against edges or underneath conduits. Photo 24

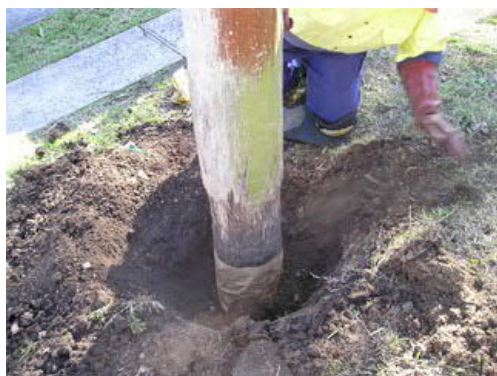
**Step 5:** Total coverage is to be achieved. Photo 25

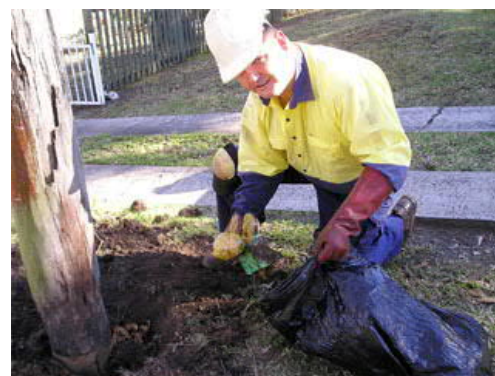
**Step 6:** Waste to be collected in plastic bag provided. Photo 26

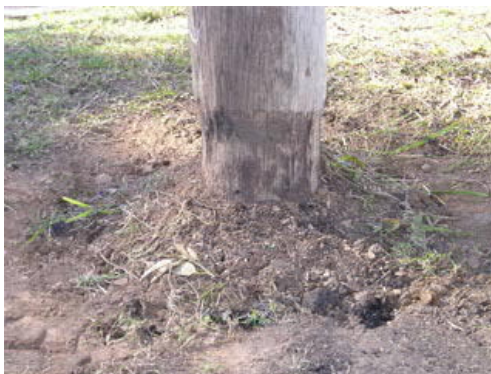
**Figure 34: Application method for Ausplast**

**Step 7:** Backfill hole in the normal manner. Photo 27

Ausplast wrap is **not** to extend above ground level.

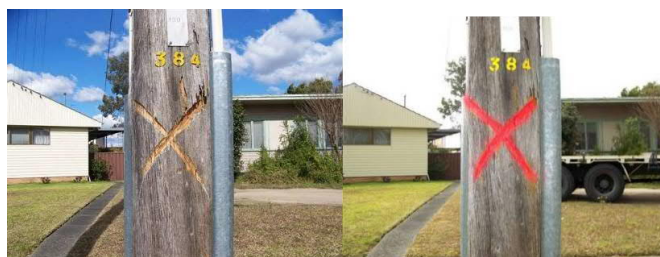
**Figure 36: Marking of immediate priority condemned poles**

These poles must be marked with an **X**, cut into the pole at 1.5m to 2.0m above ground level. The mark must then be sprayed with high visibility red paint. Concrete, composite or steel poles are to have an **X** sprayed with high visibility paint only.

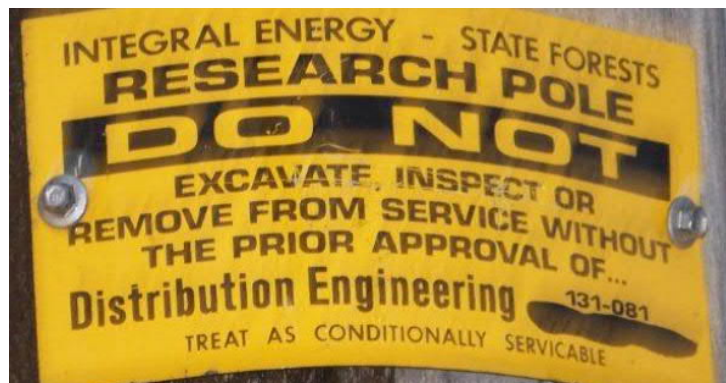
**Figure 38: Trial pole marking**

Poles that are currently being used in chemical treatment trials are marked as shown in **Figure 38**. The trial for poles marked with a 50mm aluminium disc marked **OS** (attached 1.5m above ground) has finished and the poles are to be inspected normally.

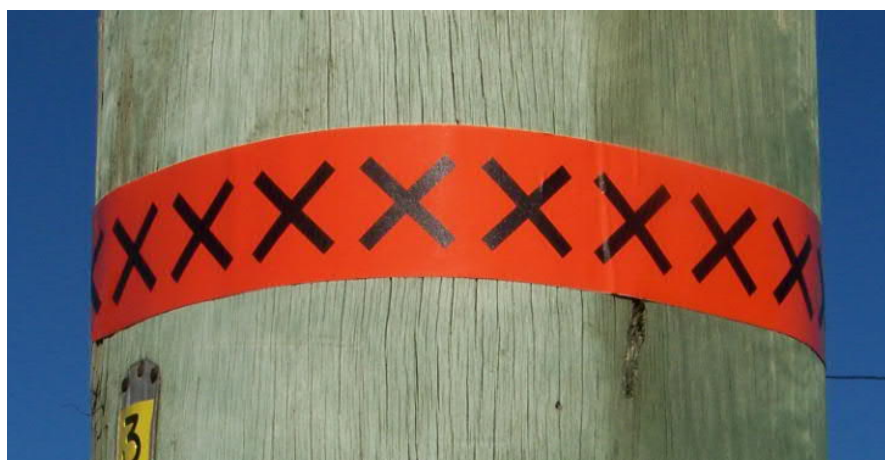
**Figure 39: Condemned pole tape**

Condemned poles must have a high visibility self-adhesive tape attached at least two (2) meters above ground. The tape must be wrapped around at least two (2) times the full circumference of the pole to reduce the possibility of becoming loose. Details of the tape are shown below.

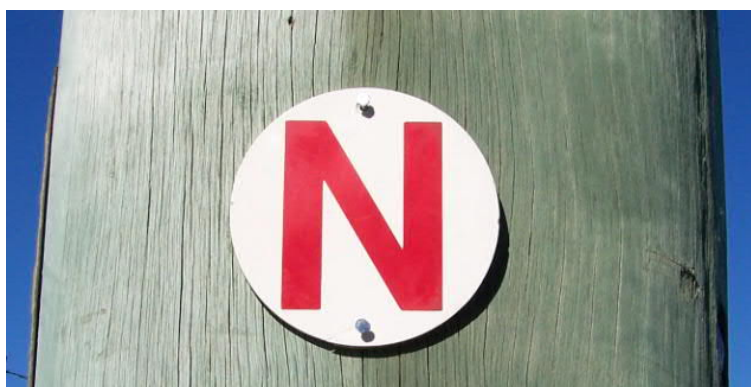
**Figure 40: Suitable for nailing pole disc**

The suitable for nailing pole disc identification must be an **N** as set out below.

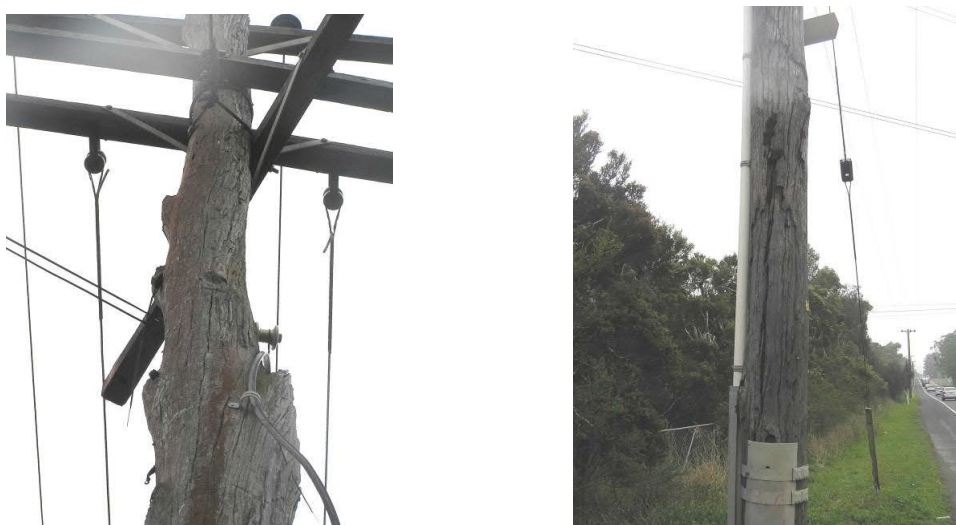
**Figure 41: Example of poles considered for replacement due to the above ground condition**

The general above ground condition of the pole must be closely inspected however, and only those poles in good order marked for reinstatement. An excessive number of knot holes, open knot holes and severe pole head degrade would normally require the pole to be replaced. Also, poles must not be reinstated if there is evidence of termites.

The example below is a pole that although it may have passed the safety factor requirement for nailing, it should be considered for replacement due to the above ground condition.

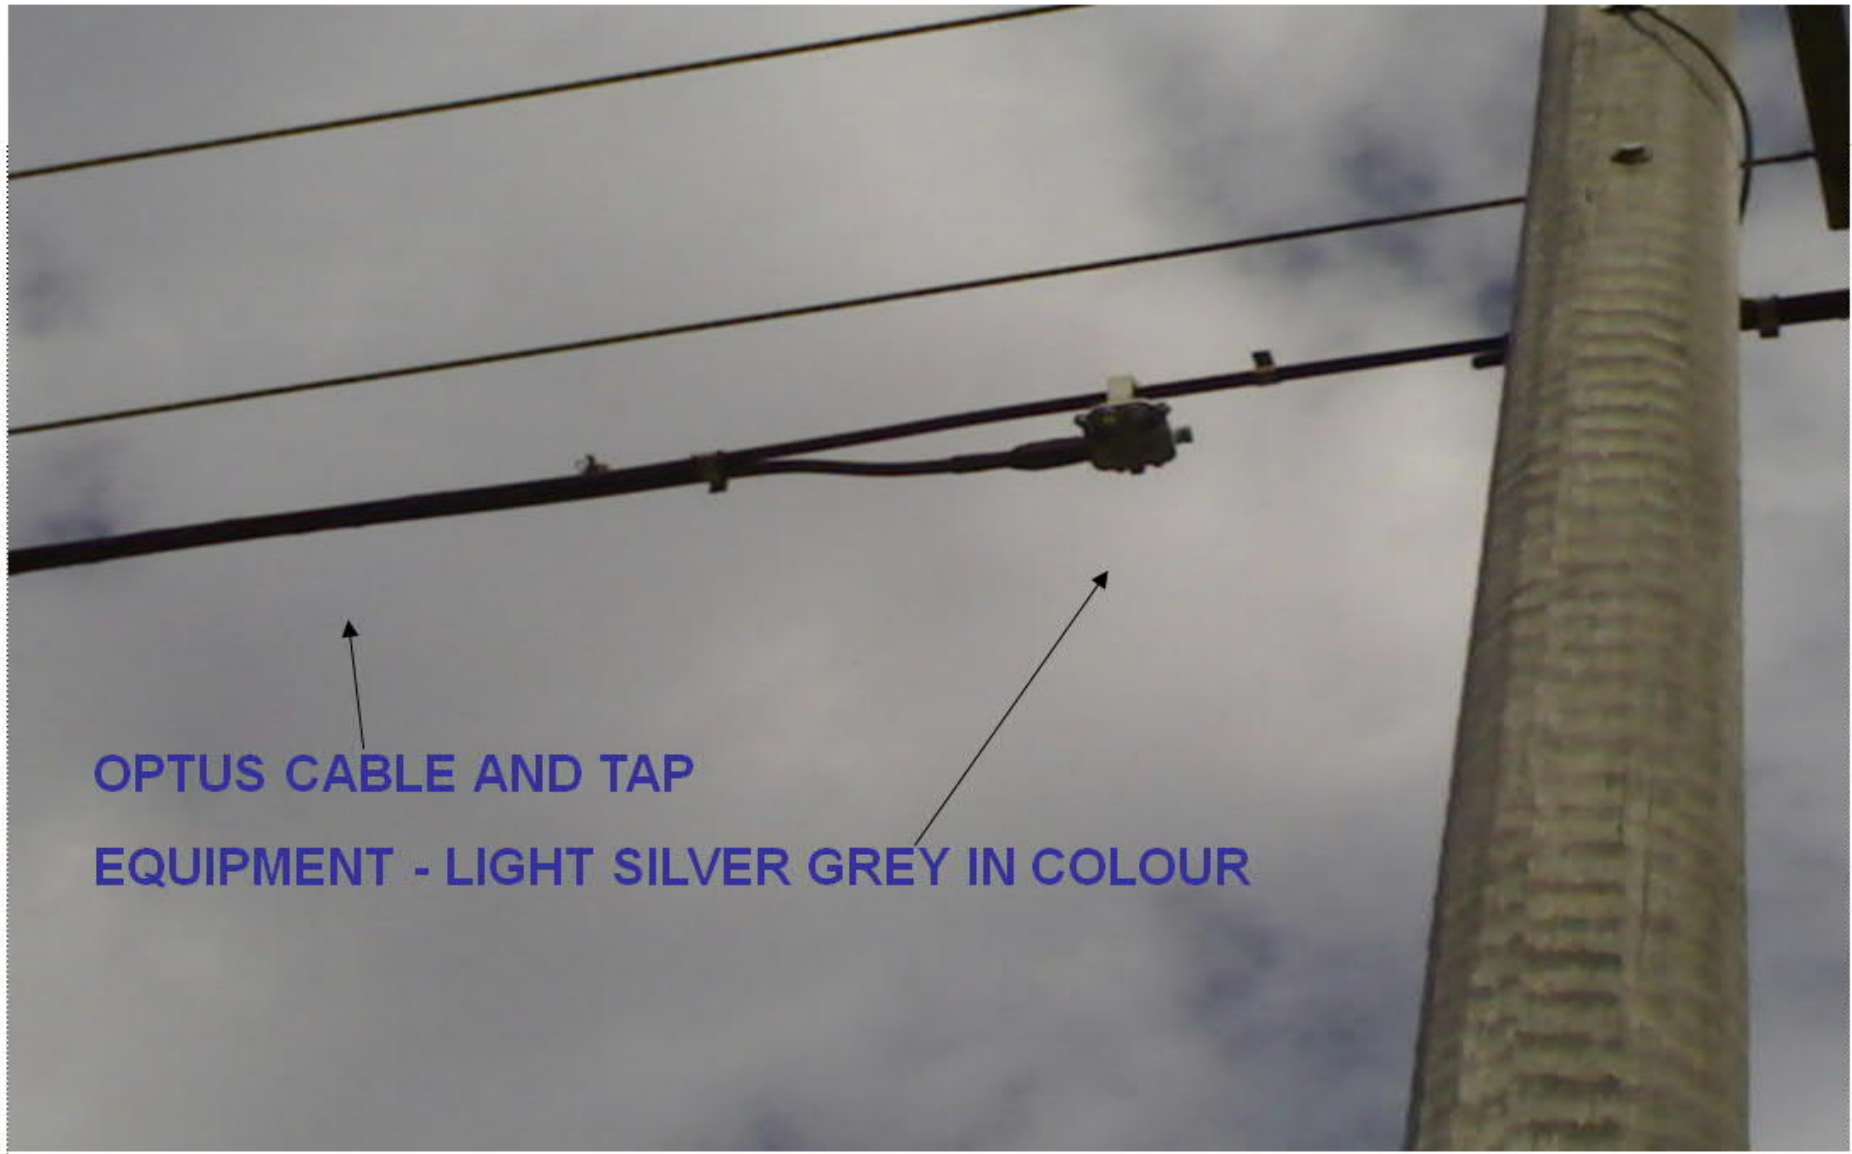
# Optus cable and tap device

OPTUS CABLE AND TAP

EQUIPMENT - LIGHT SILVER GREY IN COLOUR

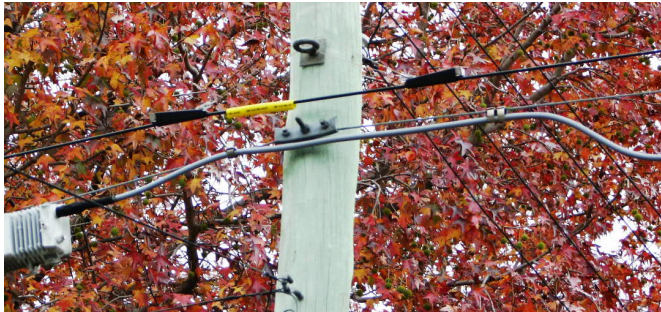
NBN Co self supporting Fibre to the Premise network yellow cable marker. Smaller markers may be used on most attachment points to poles
